WATERFRONT FACILITIES INSPECTIONS AND ASSESSMENTS

NORTHERN INDIANA PUBLIC SERVICE COMPANY
MICHIGAN CITY, INDIANA

INSPECTION DATE: JUNE 14, 2018
REPORT DATE: JULY 12, 2018

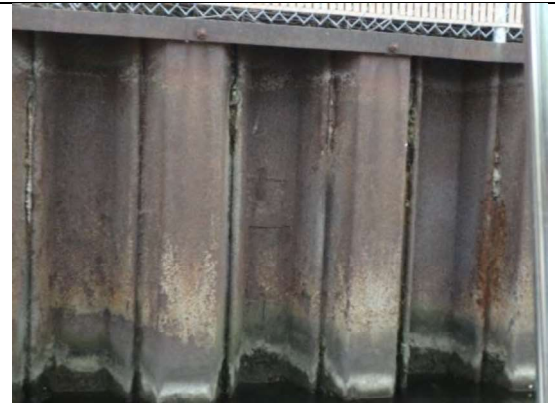
The bulkhead is in Fair condition. The sheet pile surfaces above water exhibit minor corrosion with pitting less than 1/16-inch deep and the surfaces below water typically exhibit minor to moderate corrosion over 100 percent of the surface area consisting of scaling up to 1/4-inch thick and pitting up to 1/16-inch deep. Water seepage is evident through the interlocks. Additionally, isolated areas of Microbial Induced Corrosion (MIC) are present on the sheeting.

Typical sheeting condition

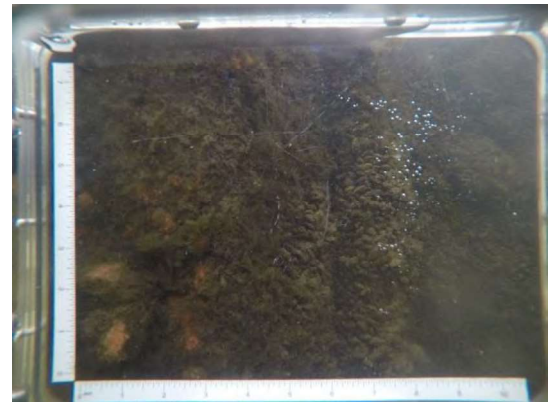
Typical sheeting below water

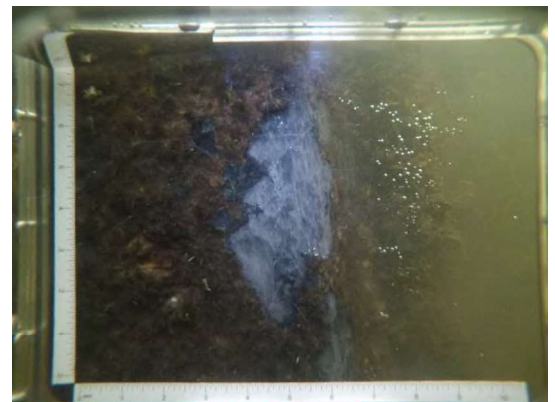
Typical sheeting condition below water, growth removed

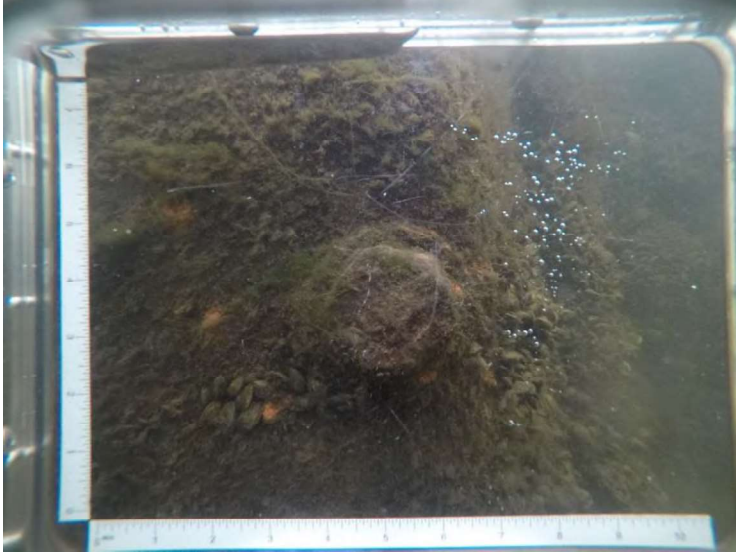
Tieback below water

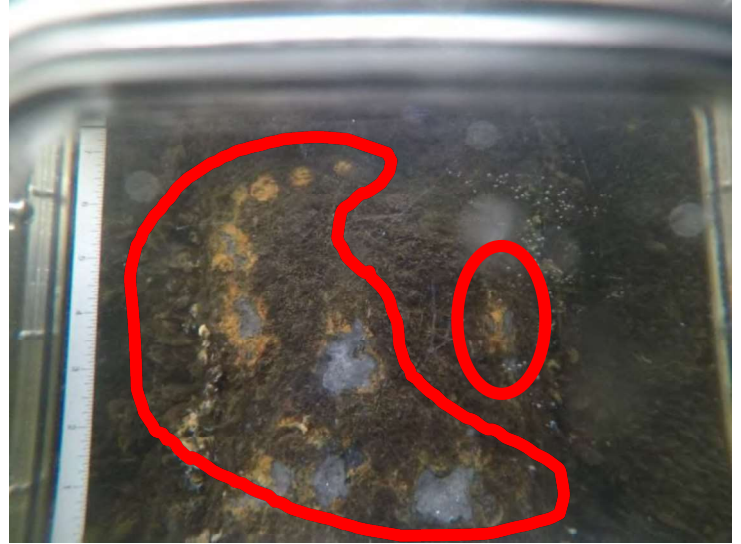
5. The steel sheet piles exhibit isolated areas of microbially induced corrosion (MIC).
6. The steel sheet piles exhibit minor impact damage of up to 2 inches of deflection throughout the bulkhead.

Area of MIC on sheeting below water

| STRUCTURE | PRIORITY | RECOMMENDATION |
|---|---|--|
| | Medium | Replace backfill in areas of washout Test for microbially induced corrosion (MIC) Replace tiebacks in areas where bulkhead is leaning outward. |

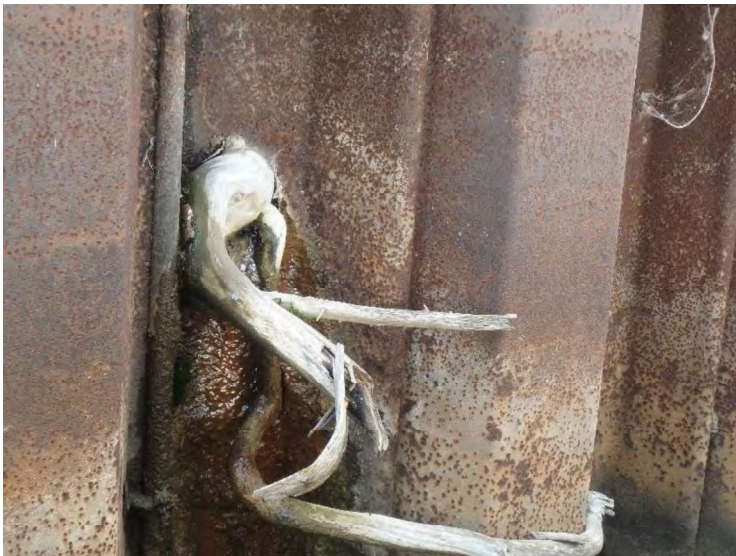
9. Roots growing through weep holes in the sheeting between Sta. 2+70 to Sta. 3+00.
10. Bulkhead leaning outward, up to 6 inches out of plumb, at Sta. 3+95 with a separation in the cap.

Root growing in weep hole at Sta. 2+75

| STRUCTURE | PRIORITY | RECOMMENDATION |
|---|---|--|
| | Low | Remove vegetation growing through weep holes Continue to monitor damage to the bulkhead as part of a routine inspection program |

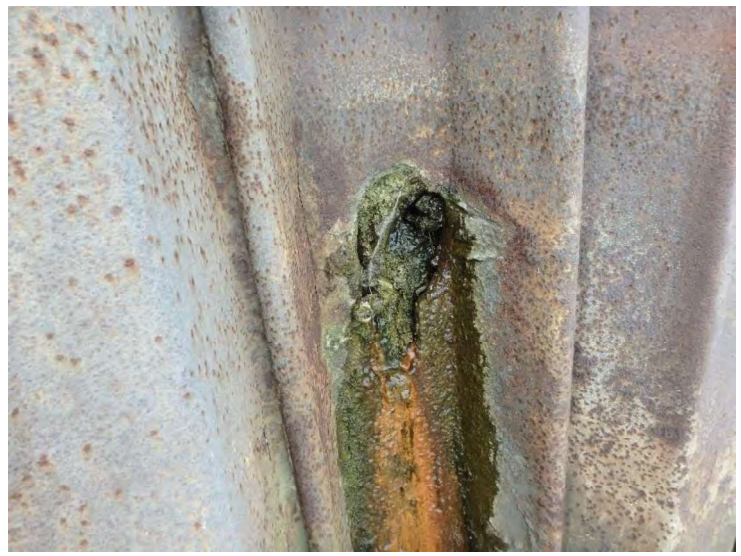
7. Evidence of water seepage through the sheet piles at interlocks was observed throughout.
8. Weep holes in the sheeting from Sta. 1+00 to Sta. 3+00 at 583.5 feet IGLD 1985 exhibit heavy corrosion with water seepage.

Corrosion at weep hole at Sta. 1+10

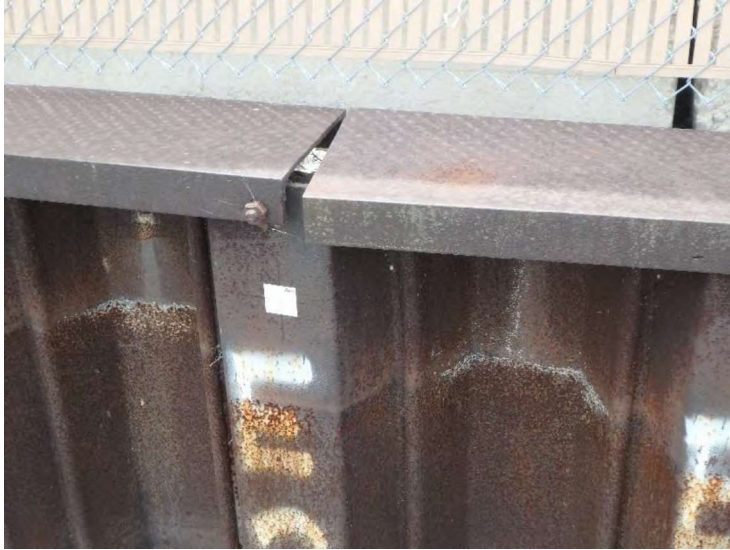
The bulkhead is leaning outward and/or out of plumb at sta. 3+95, 5+20 to 6+00 and 12+00 to 13+50. This indicates potential issues with the tiebacks and anchoring systems in these areas, however, this was unable to be confirmed as the anchoring systems are buried in earth behind the bulkhead. Additionally, the backfill is washed out to varying degrees between sta. 6+10 to 13+50.

Bulkhead leaning outward and separation in the cap at Sta. 3+95

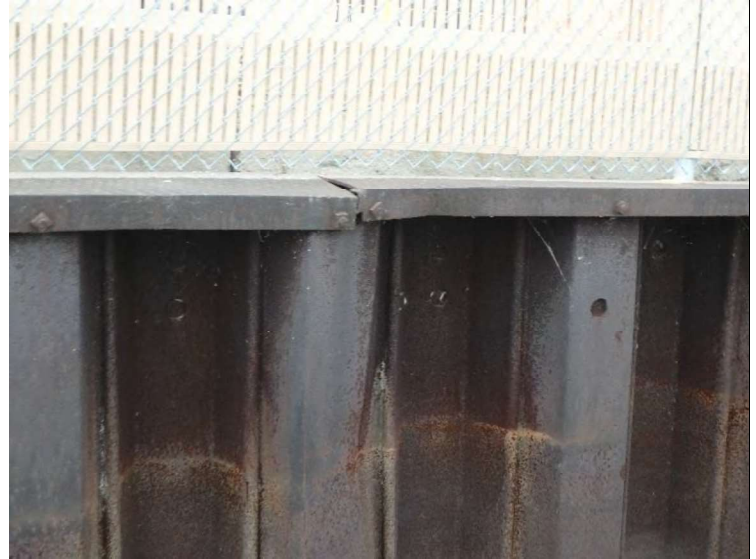
11. Area of impact damage 1.5 feet below the top of the cap at Sta. 4+90 measuring 1 foot by 1 foot with 4 inches of penetration.
12. Area of impact damage and a tear in the sheeting 3 feet below the top of the cap at Sta. 5+00 measuring 1 foot by 4 inches with 4 inches of penetration.

Area of impact damage at Sta. 4+90

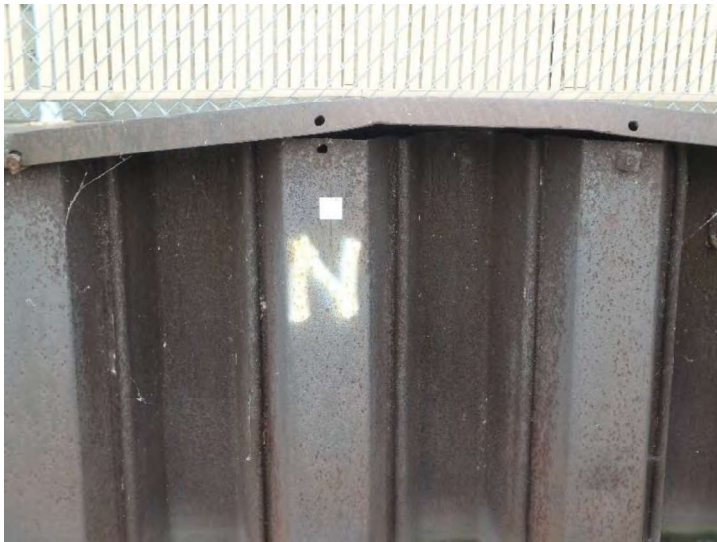
13. Bulkhead cap deflected upwards up to 5 inches between Sta. 5+20 to Sta. 6+00.
14. Area of impact damage 1.5 feet below the top of the cap at Sta. 7+00 measuring 2.5 feet by 2 feet with 6 inches of penetration.

Cap deflected upward at Sta. 6+00

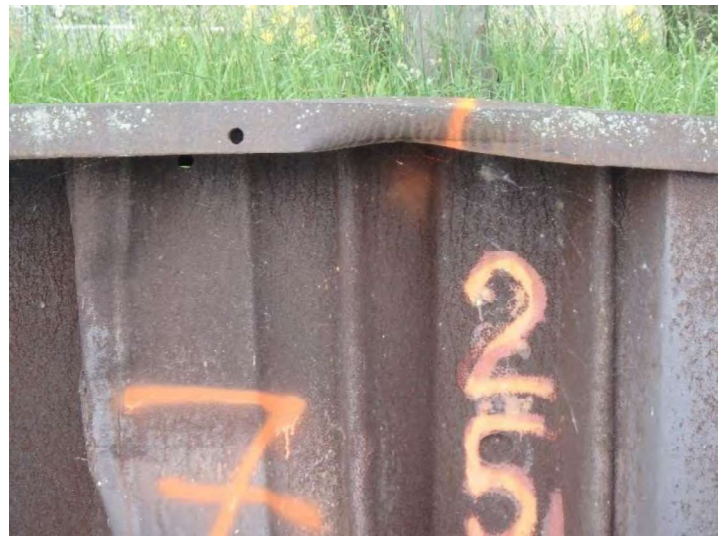
Area of impact damage at Sta. 7+00

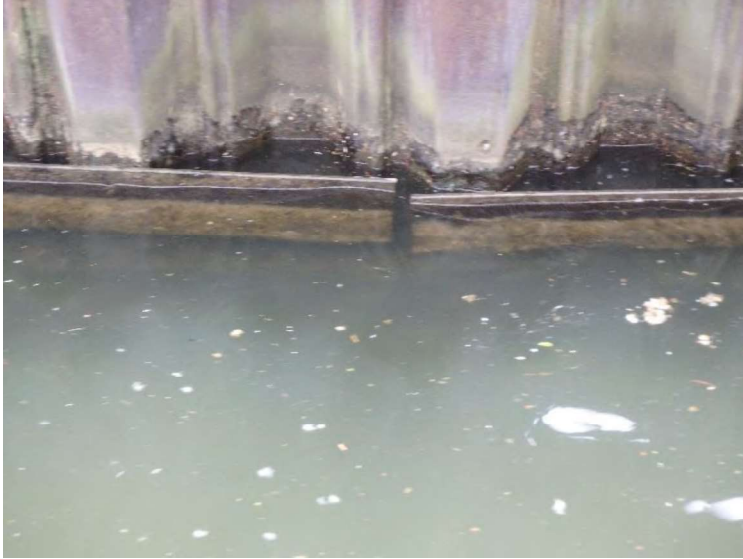
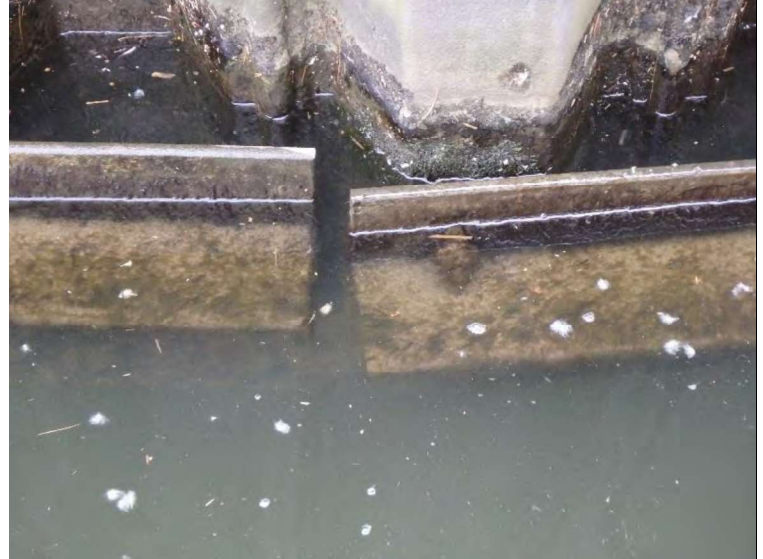
15. Area of impact damage 2 feet below the top of the cap at Sta. 7+40 measuring 1 foot by 1 foot with 6 inches of penetration.
16. The wale is detached from the sheeting at Sta. 12+00.

Detached wale at Sta. 12+00

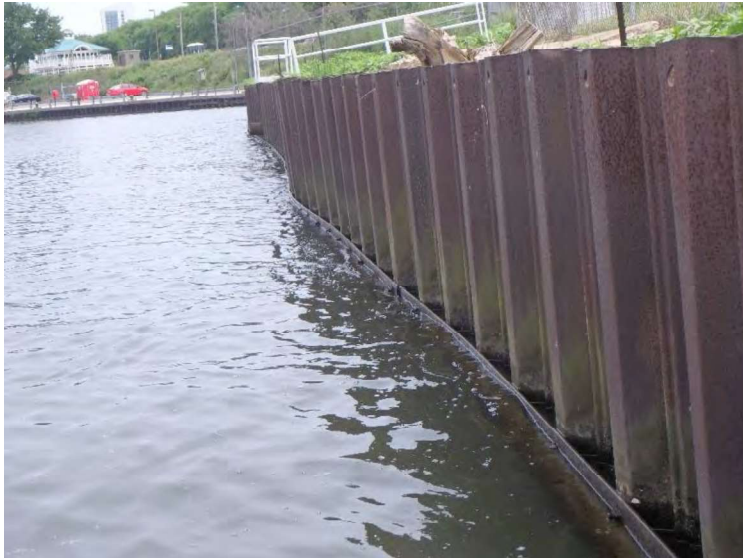
17. Bulkhead leaning outward between Sta. 12+00 to 13+50.
18. The backfill is typically washed out between Sta. 6+10 to 13+50, measuring 6 inches to 1.5 feet below the top of the bulkhead.

Bulkhead leaning outward between Sta. 12+00 to 13+50

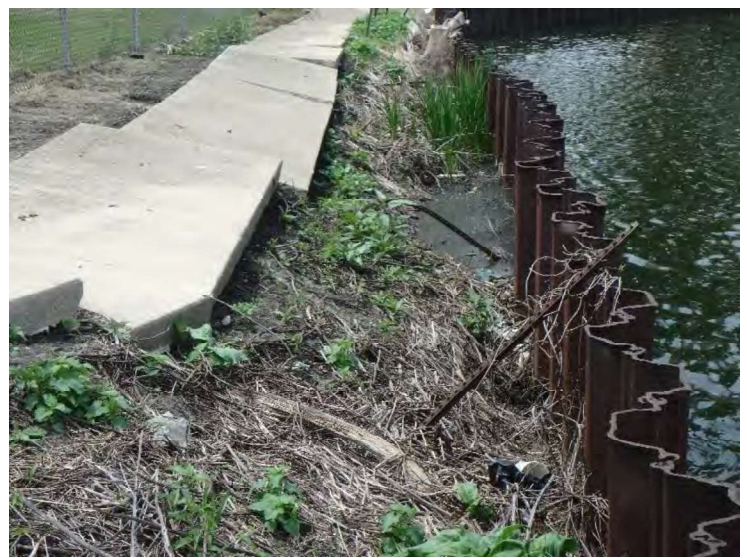
19. The backfill is washed out between Sta. 8+50 to 8+75 measuring up to 2 feet below the top of the bulkhead.
20. The backfill is washed out between Sta. 11+50 to 12+50 measuring up to 4 feet below the top of the bulkhead.

Washed out backfill at Sta. 12+00

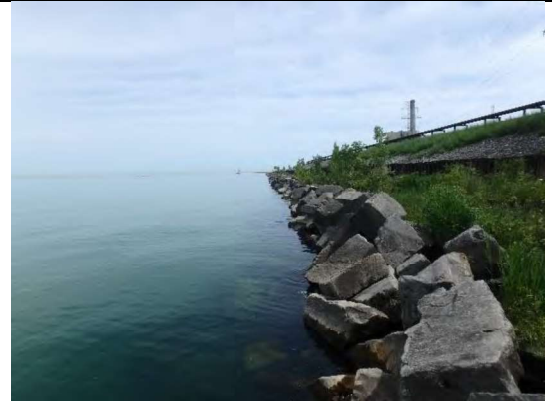
Overview looking north

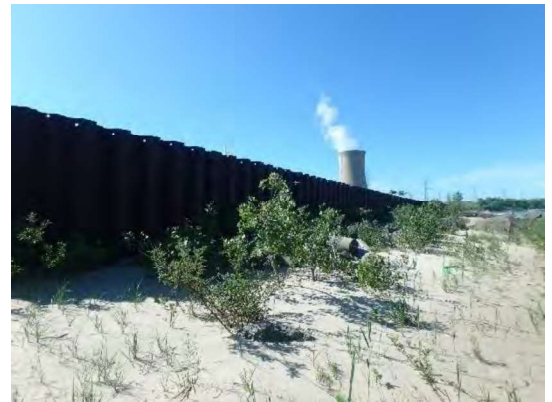
Overview of the inner bulkhead looking south

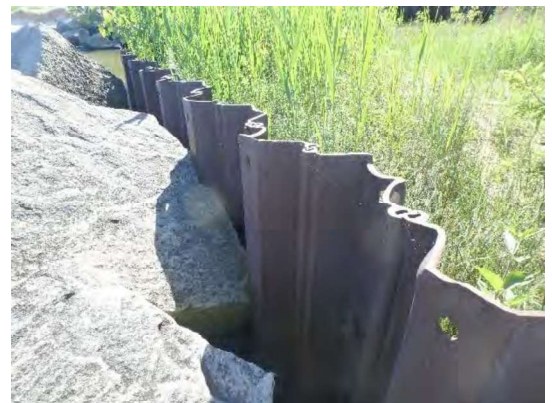
| <ol style="list-style-type: none"> The outer bulkhead sheet pile surfaces above water exhibit minor corrosion with no measurable pitting. The outer bulkhead sheet pile surfaces at the waterline typically exhibit minor to moderate corrosion over 100 percent of the surface area consisting of scaling up to 1/4-inch thick and pitting up to 1/16-inch deep. | | | | |

Typical outer bulkhead sheet pile condition above water

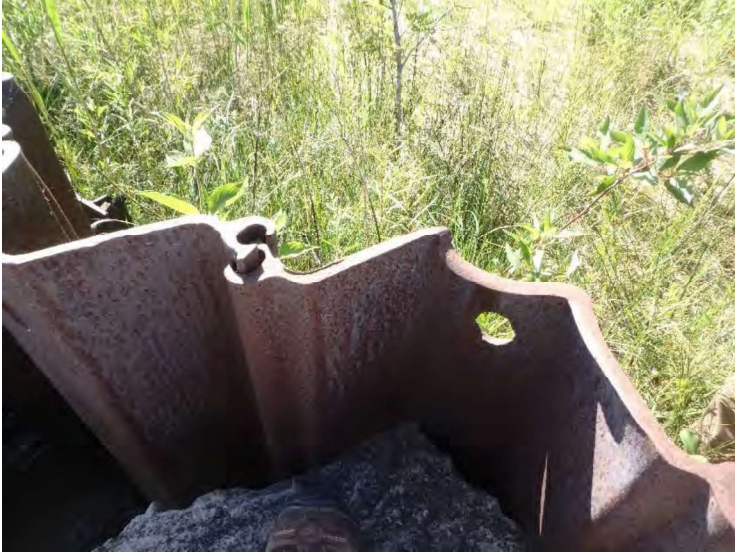
4. The outer bulkhead sheet piles upper 6 inches exhibited impact damage of up to 2 inches of deflection due to driving.
5. The outer bulkhead tiebacks and wales are broken in several areas. This is not a structural issue since rip rap has been placed on the exterior of the bulkhead.

Typical impact damage due to driving on the outer bulkhead

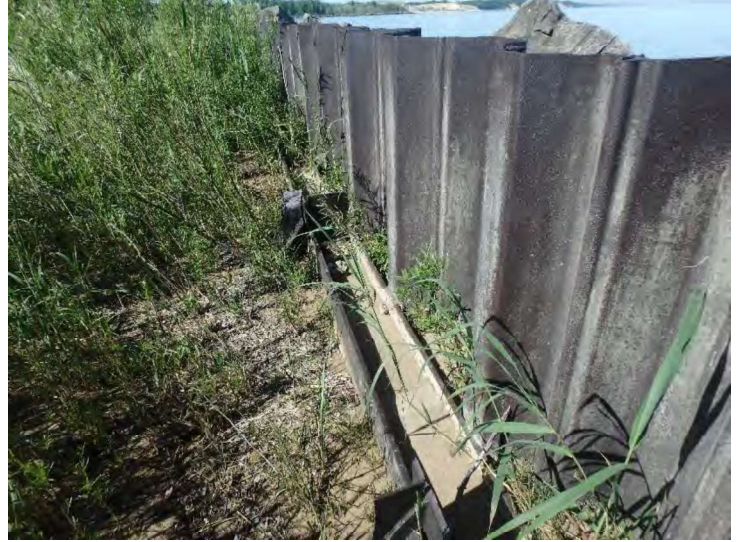
Typical condition of tiebacks and wales on the outer bulkhead

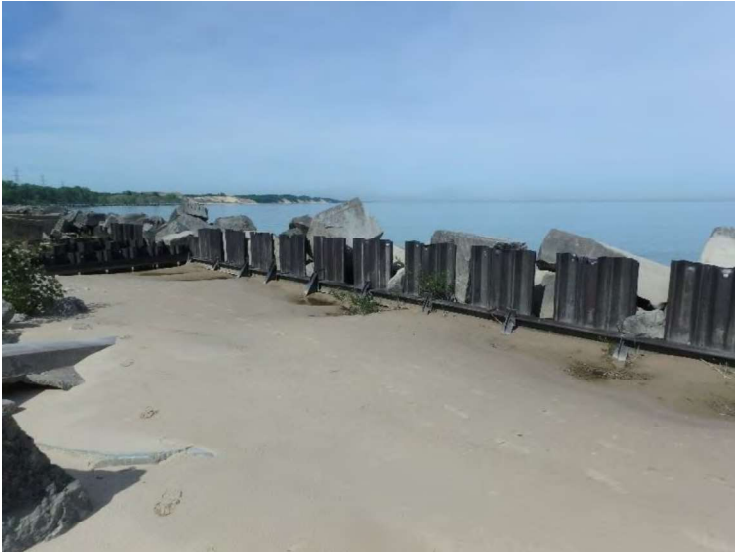
6. Several section of the upper 4 feet of sheets on the outer bulkhead have been removed in areas throughout the bulkhead to assist with drainage.
7. Evidence of water seepage through the inner bulkhead sheet piles at the interlocks was observed throughout.

Removed sheet piles on the outer bulkhead for drainage

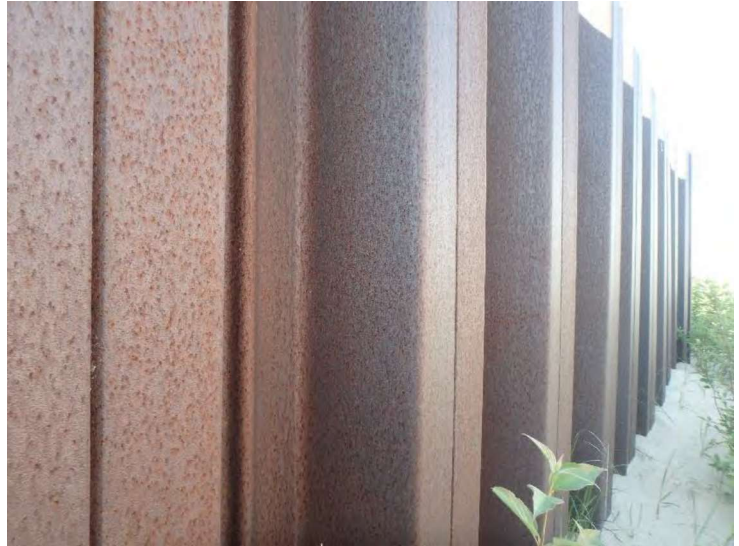
3. The inner bulkhead sheet pile surfaces typically exhibit minor to moderate corrosion over 100 percent of the surface area consisting of pitting 1/32 to 1/16-inch deep.

Typical inner bulkhead sheet pile condition

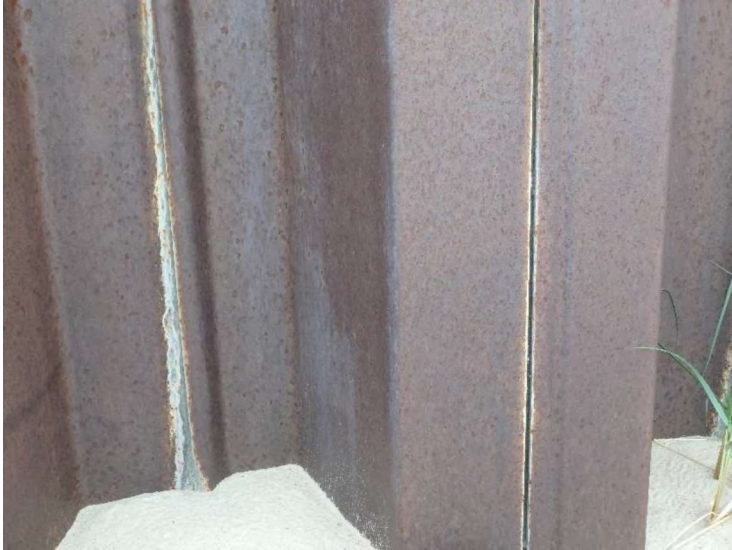
Typical seepage through the sheet piles on the inner bulkhead

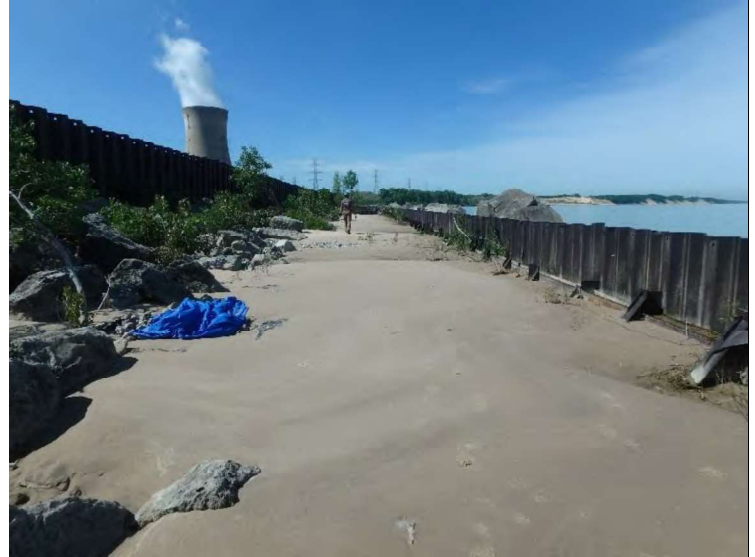
8. A low area with no significant ground protection was observed between the bulkheads from Sta. 6+50 to 9+25.
9. A low area with no significant ground protection was observed between the bulkheads from Sta. 10+25 to 12+00.

Low area between bulkheads from Sta. 6+50 to 9+25

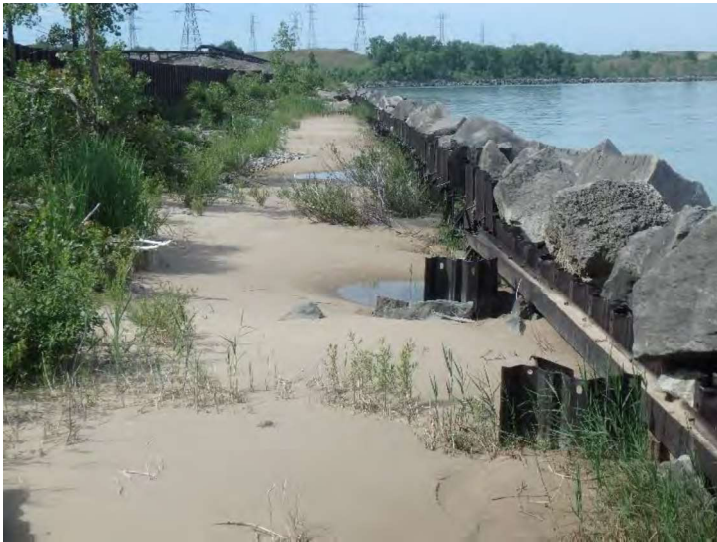
Low area between bulkheads from Sta. 10+25 to 12+00

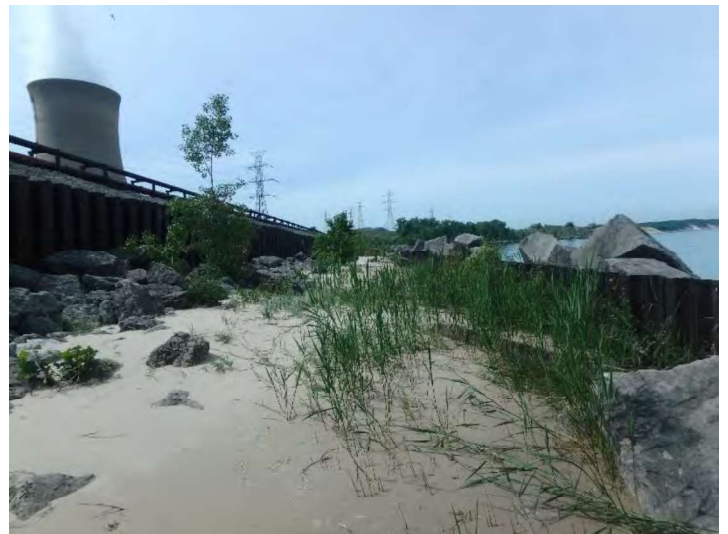
10. A low area with no significant ground protection was observed between the bulkheads from Sta. 16+00 to 21+00.

Low area between bulkheads from Sta. 16+00 to 21+00
