Natural Resource Damage Assessment
Clover Flat Landfill Waste Discharges
(Riparian Destruction, Leachate, Sediment, and Low pH)
Napa County

May 15, 2020

Bryand M. Duke, Ph.D.
Senior Environmental Scientist
California Department of Fish and Wildlife

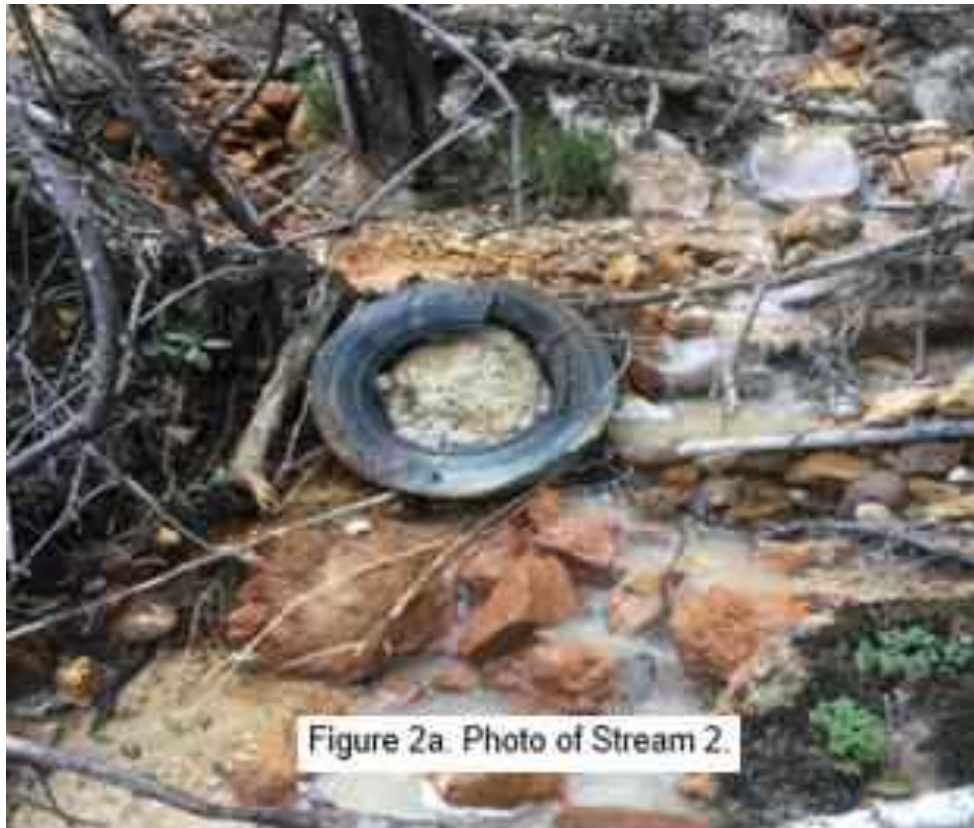
Figure 2a. Photo of Stream 2.

Officer White noted that CFL had severely polluted the unnamed tributaries (Streams 1 and 2) that flow through the landfill property (Arrest/Investigation Report by Wildlife Officer Mark White (March 29, 2019) (White 2019)). Officer White observed large amounts of earth waste spoils, leachate, litter, and sediment that were allowed to enter the streams. (See Figures 2a, 2b. Figure 2b is the reference site.) CDFW staff also observed several hundred linear feet of stream covered in side-cast rock, boulder, and mineral earth waste spoils (White 2019). Stream 2 had been severely altered without any notification to CDFW and there was essentially no aquatic life present in sections of Stream 1 (White 2019). Officer White documented evidence of violations of Fish and Game Code sections 1602(a)(1), 5650(a)(6), and 5652(a) (White 2019).

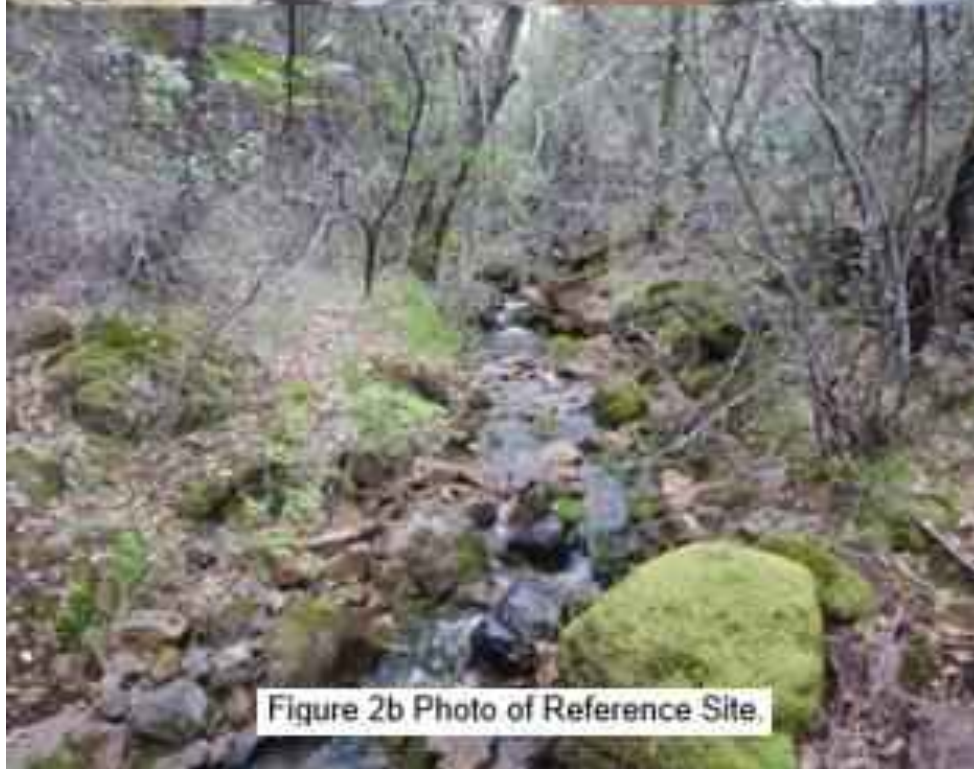
Figure 2b Photo of Reference Site.

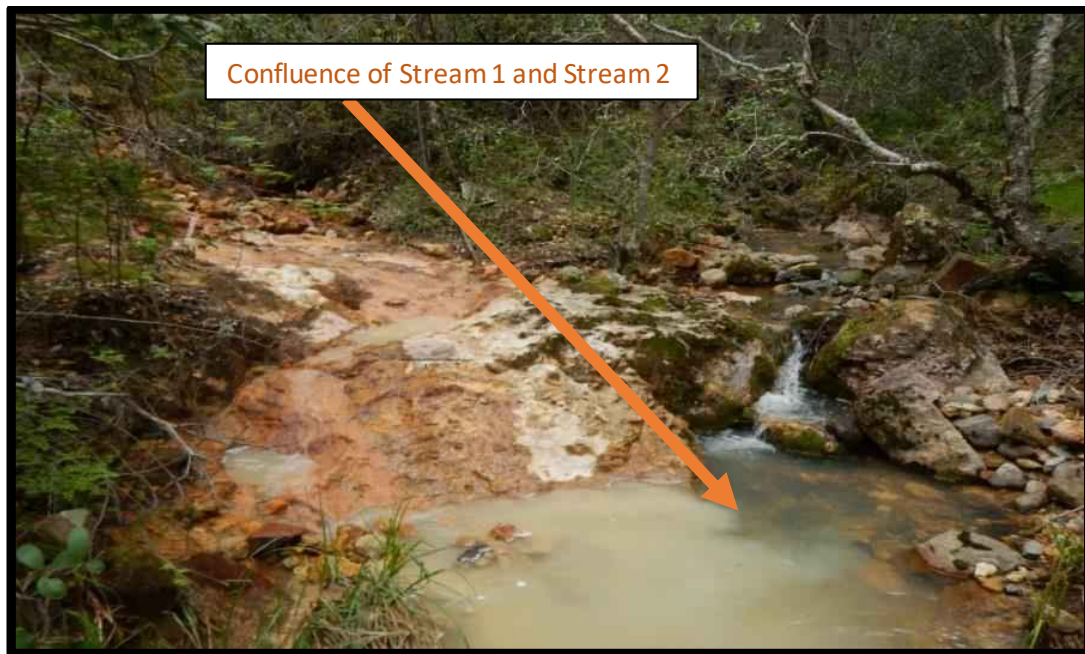
Figure 5. Confluence of Stream 2 (left) and Stream 1 (right). Orange coloration can be observed in Stream 2 and no orange coloration was observed in Stream 1. Likewise, moss was not observed on rocks in Stream 2, however, moss was observed on the rocks in Stream 1 (Allen 2019).

Uncontained sediment and erosion discharged from the CFL site into the downstream receiving waters, resulting in substantial adverse impacts to fish and wildlife (Figure 5). Increased sediment delivery from the CFL is deleterious to aquatic species and their habitat. Excess fine sediment (i.e., fines) deposited into waterways can have significant effects on fish and wildlife species. Fines that stay suspended in the stream can be deleterious to fish because it significantly increases the water's cloudiness or turbidity, and many fish species are sight feeders, and therefore, rely on water clarity for foraging success. In addition, turbid waters can also cause fish to spend energy to rid their gills of sediment by coughing, which erodes sensitive gill tissues, thereby inhibiting growth or even resulting in fish mortality (Allen 2019; Berg and Northcote, 1985).

Orange coloration (Zone 2; Figure 5) on sediment was also observed in Stream 1 after the confluence of Stream 2. No orange coloration was observed at the reference site (Figure 5; Sibbald 2019).

Orange coloration was also observed on sediment and rocks in Zone 3 (Sibbald 2019). However, no orange coloration was observed at the reference site in Figure 5 (Sibbald 2019).

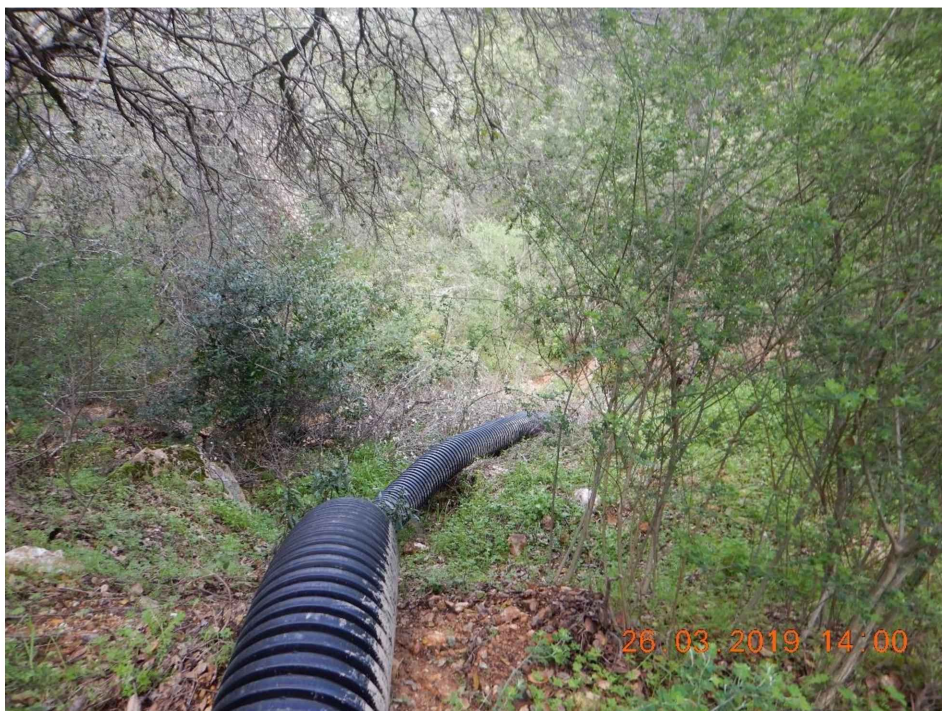
Figure 1. Photo 575 - pipeline from the landfill into the creek, looking east. (See San Francisco Bay Regional Water Quality Control Board, SFBRWQCB NOV Report, dated March 29, 2019).

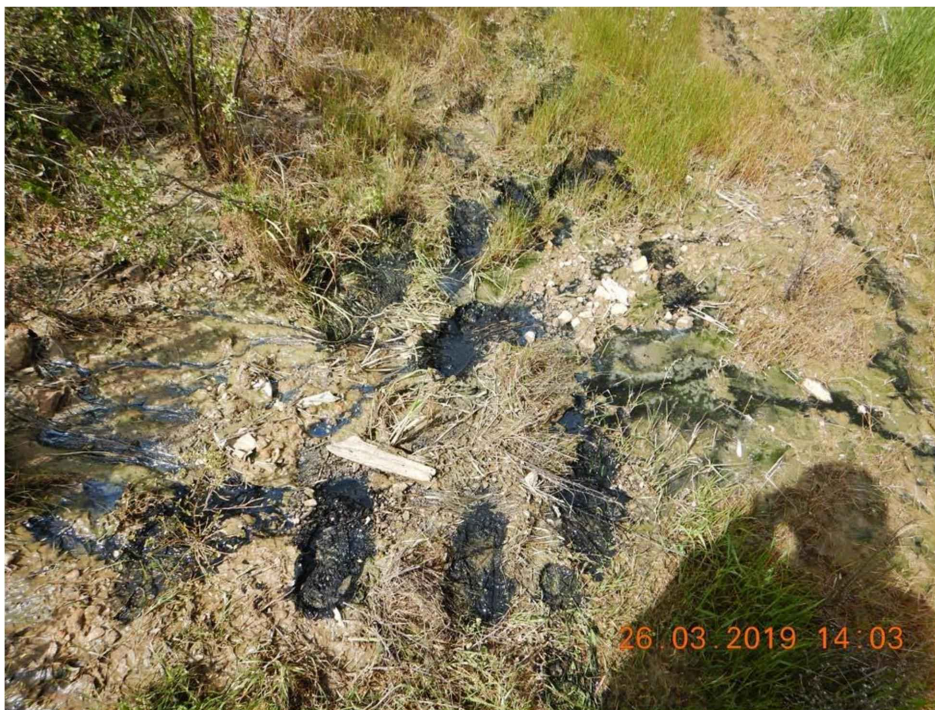
Figure 2. Photo 589 - black, oily-looking material flowing toward the creek, looking northeast. (See San Francisco Bay Regional Water Quality Control Board, SFBRWQCB NOV Report, dated March 29, 2019).

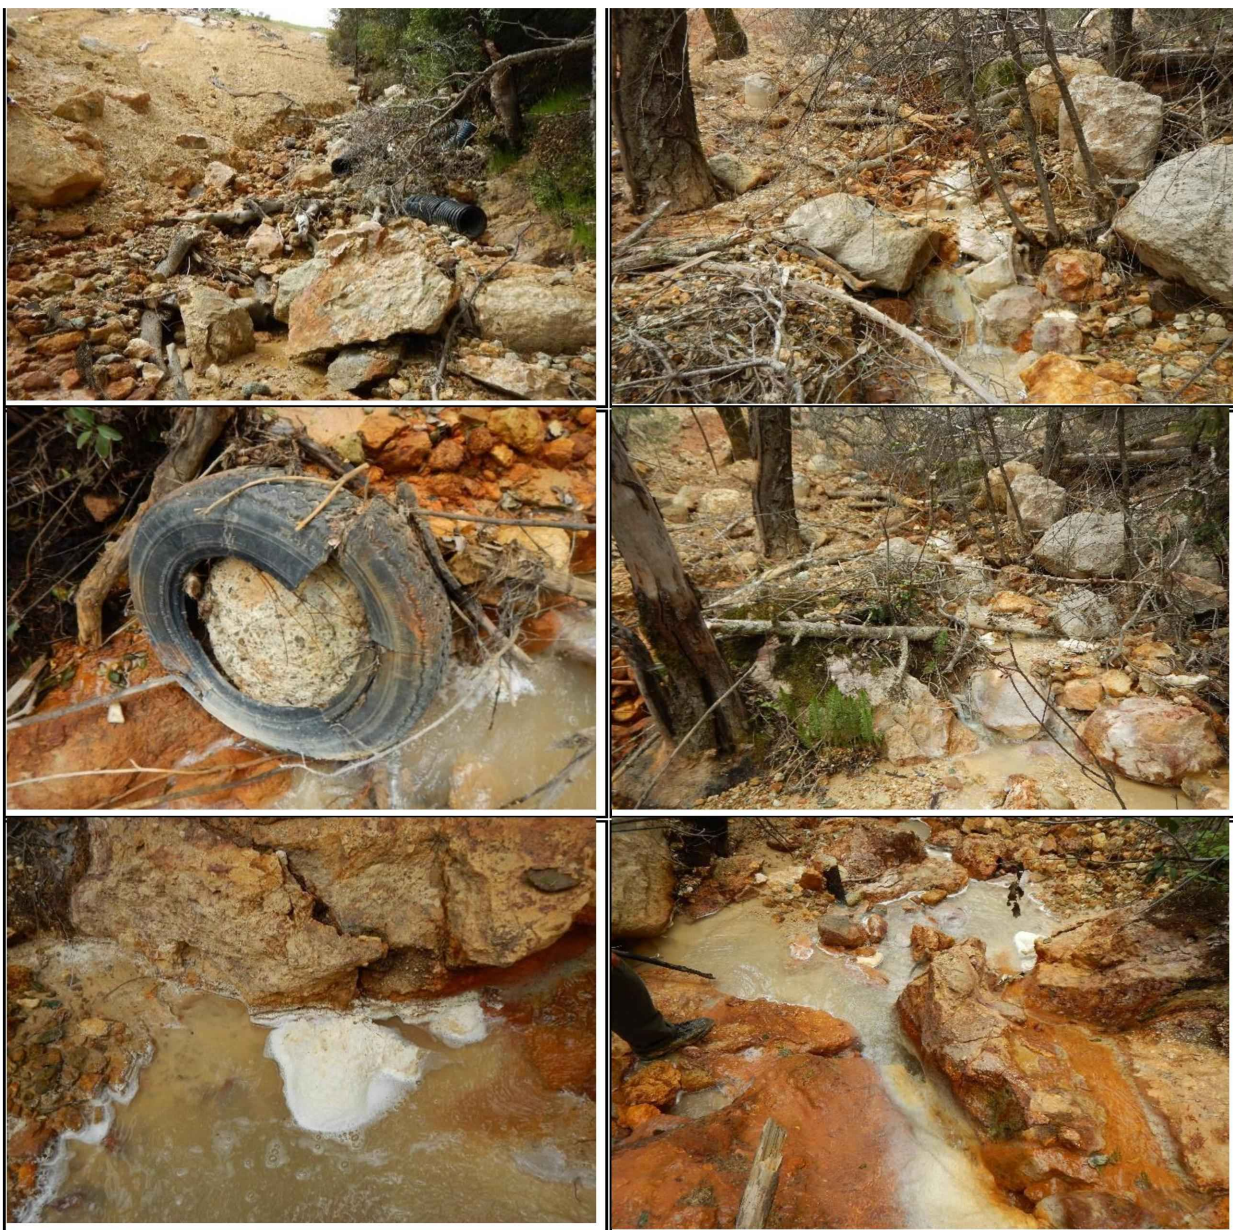
Figure 3. Representative views of Stream 2 (April 2, 2019), downstream of the leachate entering the stream (Allen 2019).

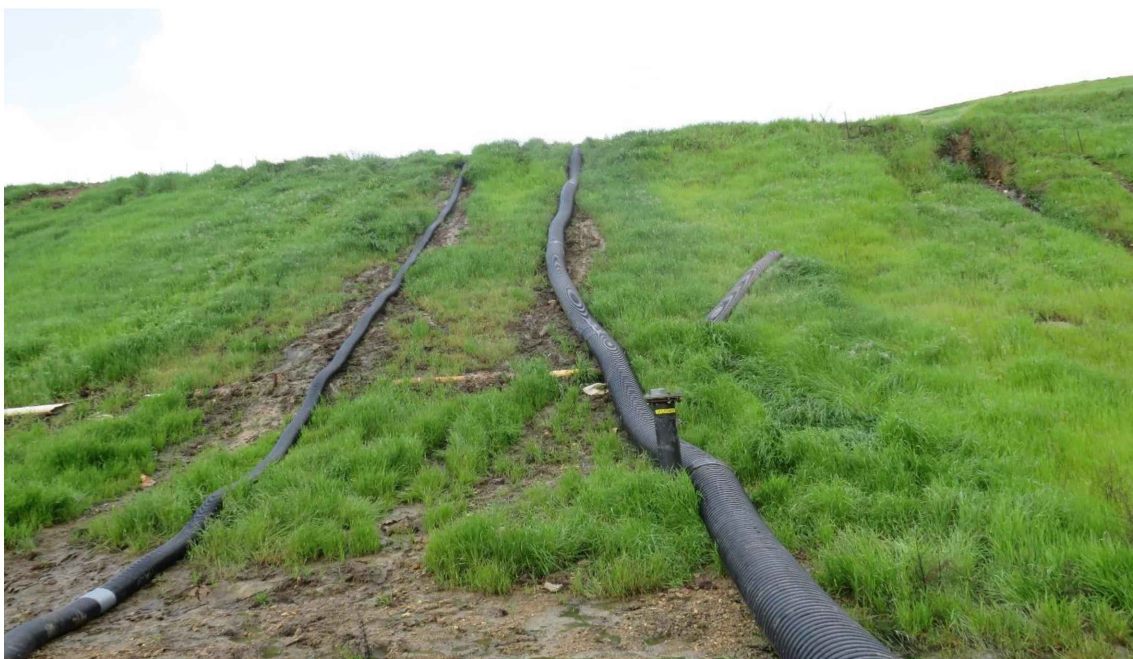
Figure 4. Looking upslope toward active landfill (not in view). Black plastic storm drain pipe on right originating from landfill travels down slope into Stream 1 (March 28, 2019) (Allen 2019).

A substantial amount of riparian canopy was removed from the Stream 2 riparian area (Figure 4) and the Stream 1 riparian area (Figure 5, Appendix C) at the CFL location between May 2014 and August 2014 (Allen 2019). This removal resulted in the loss of riparian function for terrestrial and aquatic species on-site. Mature riparian trees and mid-canopy vegetation will take considerable time to reestablish, grow and function (Allen 2019). The temporal loss of riparian habitat reduces shading, which will increase water temperature, and results in deleterious impacts to aquatic organisms. Reduction of riparian vegetation also can result in decreased stream bank stability. Riparian areas are of critical importance to protect and conserve the biotic and abiotic integrity of a watershed (Allen 2019). Riparian buffers provide a microclimate, a source of large woody debris, and act as filter strips (Allen 2019). As a filter strip, riparian buffers also aid in keeping pollutants from entering adjacent waters through a combination of processes including dilution, sequestration by plants and microbes, biodegradation, chemical degradation, volatilization, and entrapment within soil particles.
